# LINE OF DUTY DEATH REPORT

REPORT 2023-10 • April 2025

## ***Two Career Land-Based Firefighters Die After Becoming Lost and Running Out of Air During a Marine Vessel Fire in Port – New Jersey***

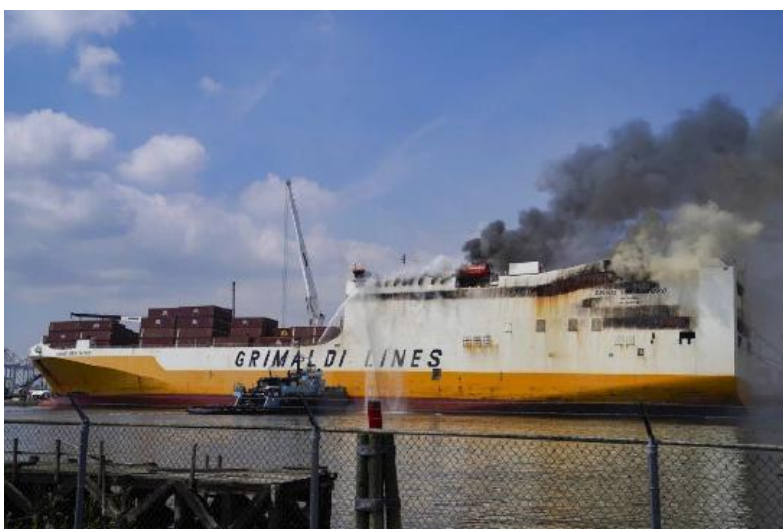
**Photo 1: A view of the marine vessel fire in port.  
(Courtesy of U.S. Coast Guard)**

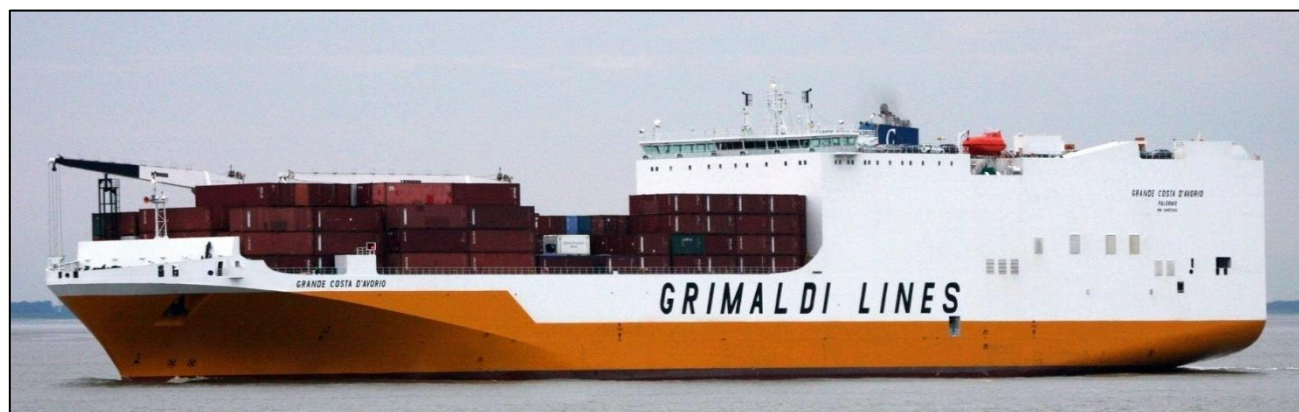
**Photo 2. View of the vessel showing the open cargo container storage area in the front half of the vessel and the enclosed vehicle storage area in the rear half of the vessel.**

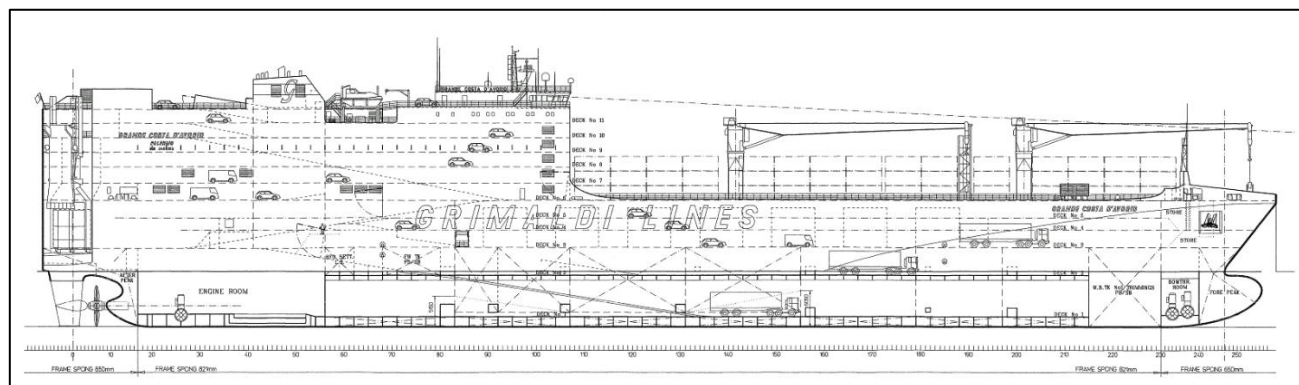
**Diagram 1. View of the vessel showing the deck and cargo layouts.**

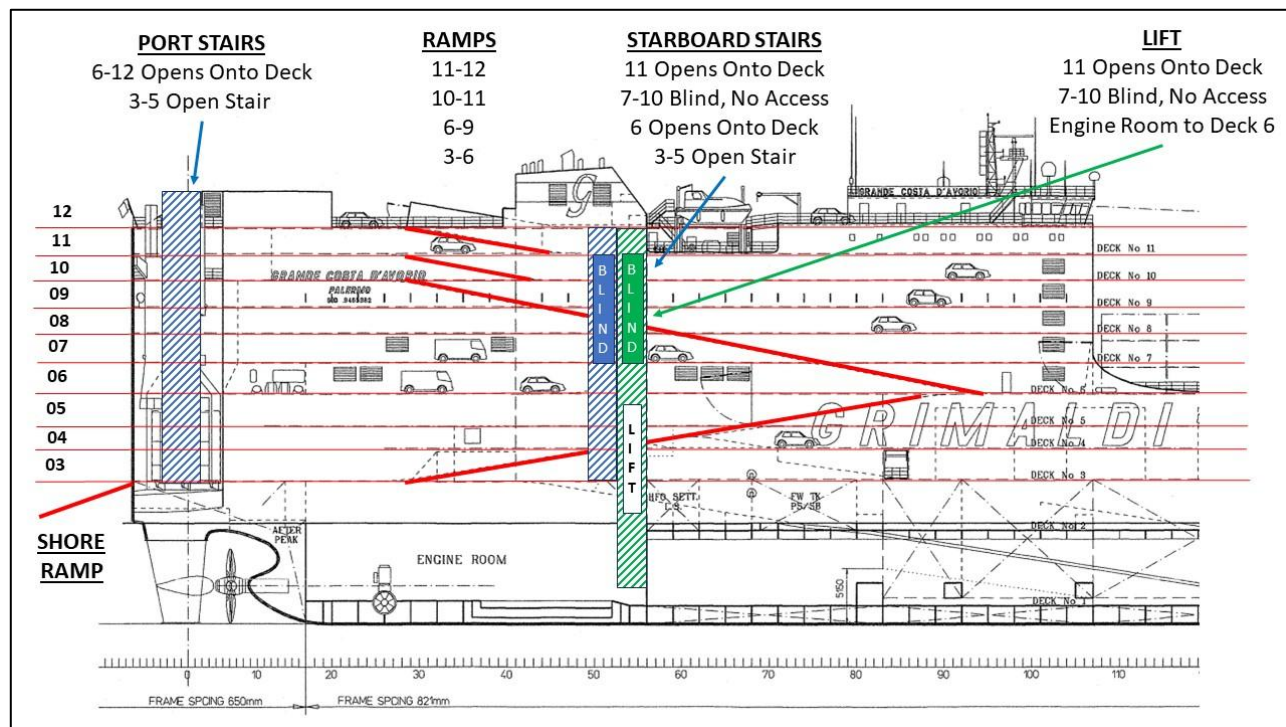
Diagram 2. View of the vessel showing the access between the various decks including ladderwells, the personnel lift (elevator), and vehicle ramps.

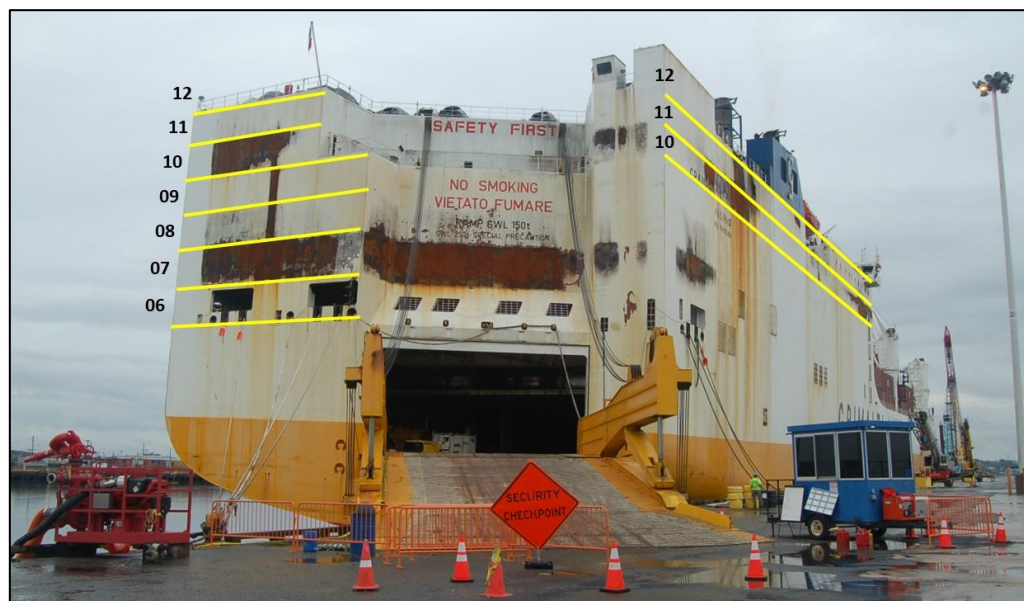
Photo 3. View of the vessel from the rear/stern with the deck levels noted. The rear/stern vehicle ramp is shown, which was used by all personnel during the incident to access deck 3.

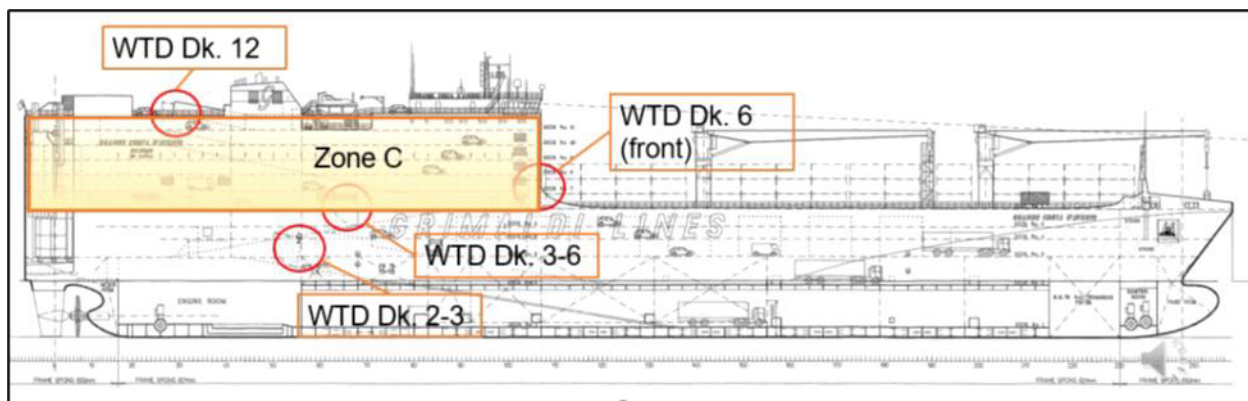
**Diagram 3. Vessel fire protection zones and weather tight doors (WTDs).**

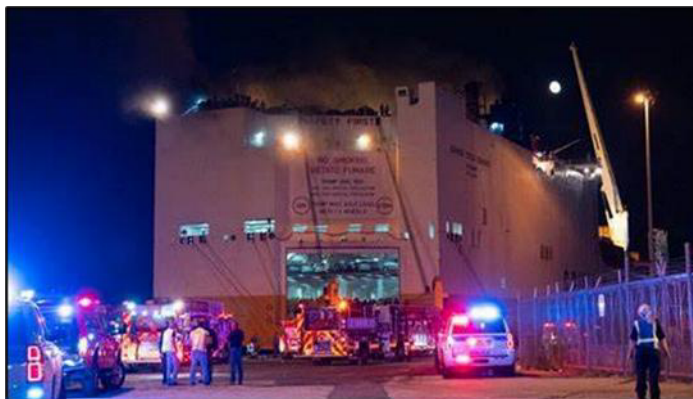
**Photo 4: A view of the vessel and the conditions at the time of the fire department arrival.**  
*(Courtesy of U.S. Coast Guard)*

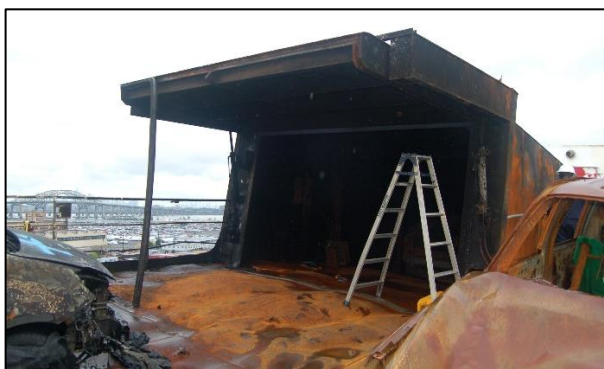
At approximately 22:00 hours, the vessel's Chief Mate and Bosun reported to the WTD on deck 12. They determined that given the improvement in conditions and reports of no fire on deck 11, they could attempt to close the WTD (see **Photos 5 and 6**). An attempt was made to close the door, but a fault/malfunction light appeared on the control panel indicating that the door would not operate. They decided to cease and consider other options.

**Photo 5. WTD on deck 12 that failed to close.**

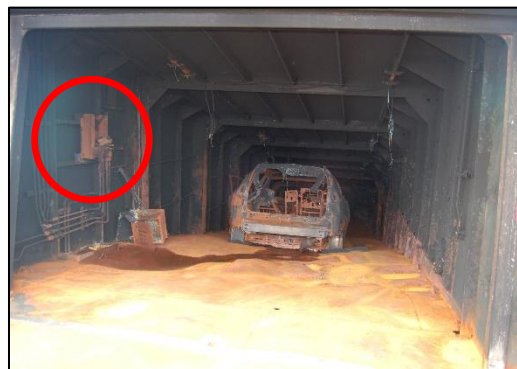
**Photo 6. Inside the WTD, showing the door controls on the left.**

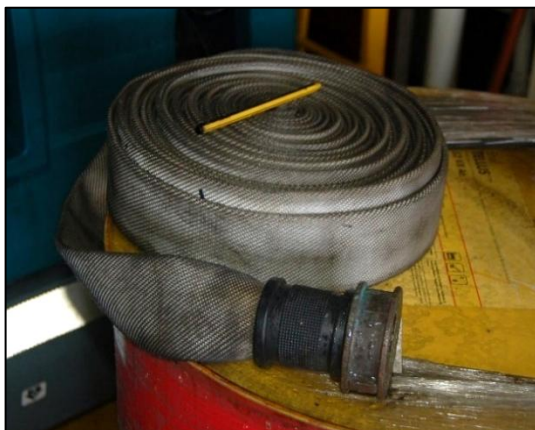
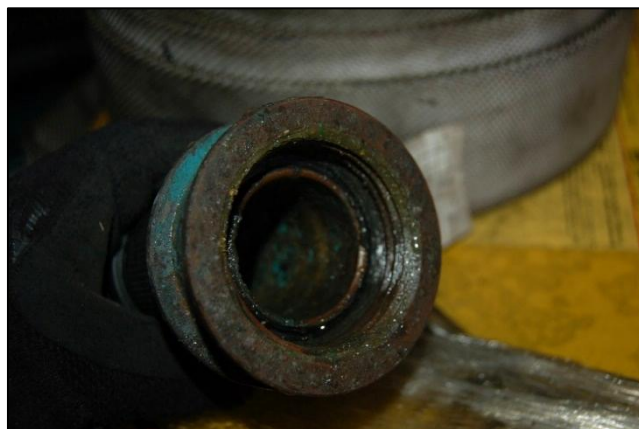
Between 22:06 and 22:12 hours, there were requests for firefighters to bring additional lengths of hoseline to deck 12. The original plan was to connect the fire department hose to the vessel's hose station so that a hoseline could be extended from deck 12 to deck 10 for fire attack. Once the firefighters attempted to connect the fire department hose to the vessel's hose station, they realized that the hose fittings were not compatible. The vessel's hose was a 1½ metric diameter with an international coupling (see **Photos 7 and 8**).

**Photos 7 and 8. Vessel's 1½ inch fire hose and coupling.**

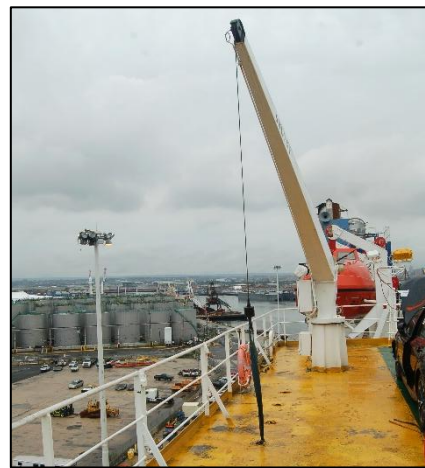
the missing firefighters to the dock (see **Photo 9**). At 23:41 hours, the first arriving mutual aid rescue company was sent to deck 10 to assist with the rescue operations. At 23:45 hours, BC4 and BC5 requested that the vessel's ventilation system be turned back on. The intent was to remove smoke and heat from deck 10 to aid the search and rescue operations. The VC contacted the Chief Engineer and advised him to reopen the dampers and restart the exhaust fans. BC5 also had a hatchway in the front/bow part of deck 11 on the starboard side opened. While these efforts did initially improve the smoke and heat conditions on deck 10, they ultimately fed fresh air to deck 11 which rapidly intensified and spread the fire.

**Photo 9. The vessel's crane used to lower the missing firefighters.**

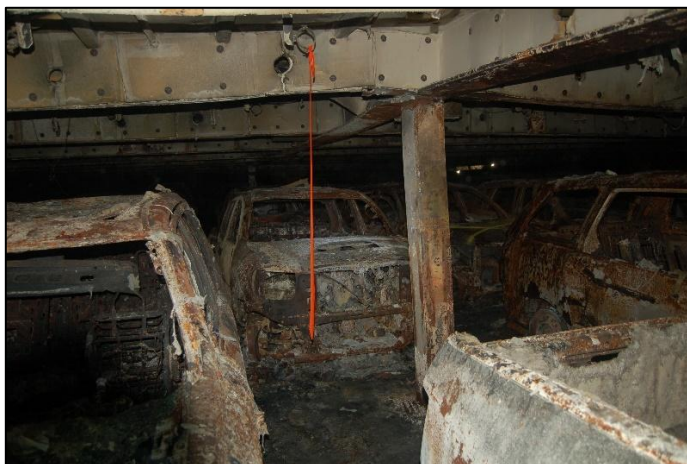
From approximately 02:00 to 02:09 hours, the third UASI search operation took place. They searched deck 10. UASI Rescue 5 (R5) split into two teams following the two search lines previously deployed. The team operating on the rope closest to the starboard side found a discarded firefighter flashlight. They took this as a possible sign that the missing firefighter could be in the area. When that team reached the end of the original search rope, they heard a PASS device sounding. They deployed an additional rope search line approximately 75 feet in the direction of where the PASS was sounding. At 02:08 hours, R5 located the missing Ladder 4 firefighter (**see Photo 10**). He had his SCBA on, but his facepiece was not in place.

**Photo 10. Location (deck 10) where Ladder 4 firefighter was found.**

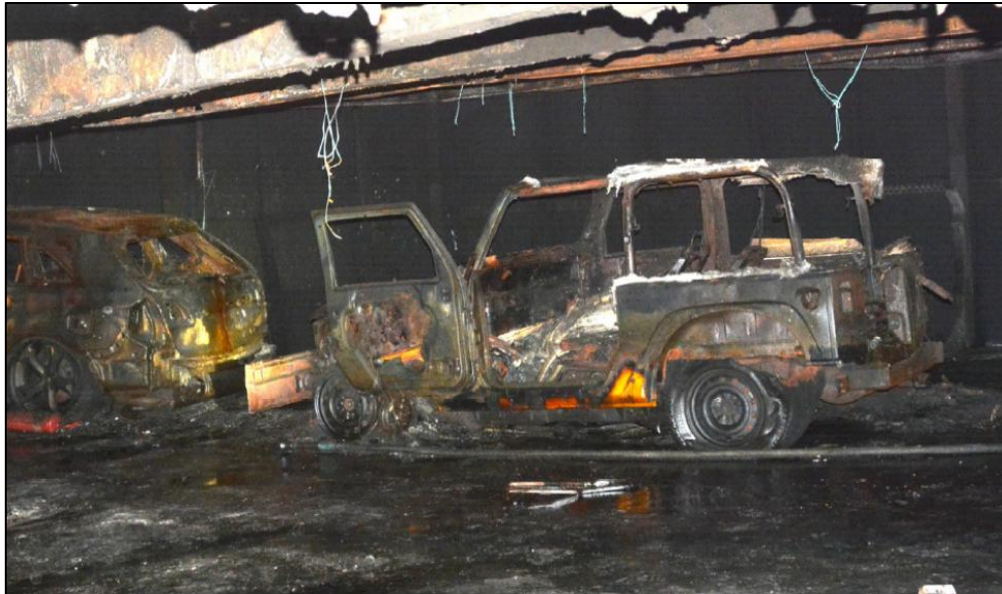
The origin of the fire was determined by the ATF National Response Team to have been from the deck 10 pusher vehicle (**see Photo 11**). The vehicle had been used throughout the day to push disabled vehicles onto the vessel. The ATF investigation determined that the transmission in the vehicle overheated, which resulted in the release of flammable transmission fluid. Several witnesses described fire “dripping down from under the vehicle” consistent with this finding. The fire was ruled as accidental.

**Photo 11. The pusher vehicle experienced a transmission failure, serving as the origin and cause of the fire on deck 10.**
